Work On Original Painting in Samarkand Afrasiab Museum

ABSTRACT: Given article is denoted of restoration activity archeologist a famous of Samarkand Archeological institute under Academy of Sciences of Republic of Uzbekistan. It is given broad artistic analysis of the process to restorations painting throne common-room of Afrasiab in accompaniment with fotoreproduction from work 2014-2017 yy. As a result of analysis modern painting with original museum of Afrasiab possible to define, not before our days of a part and fragments in holistic type that is to say in beginning, what looked before destruction arabic conqueror. Afrasiab paintings, as specific facility more than 16 centuries are studied in our republic and have a questions, which wait their own decisions. The author presents for the first time in picturesque manner to your attention, its interpretation painting, coming from its scientifically-creative experience. Given exploratory work, possible consider, as significant contribution to science on archaeology architecture and art.

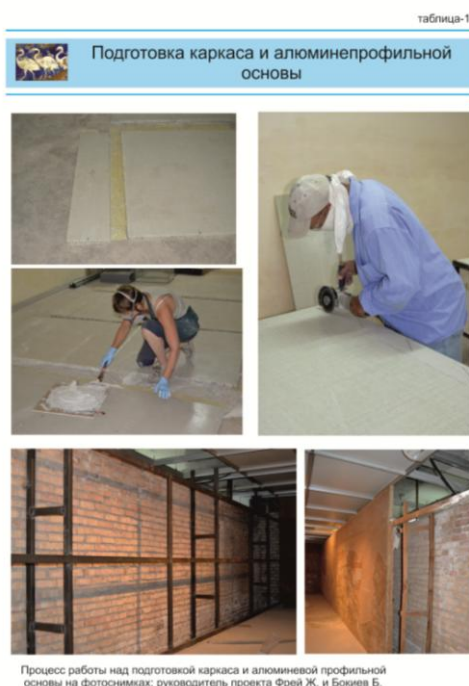
Процесс работы над подготовкой каркаса и алюминиевой профильной основы на фотоснимках: руководитель проекта Фрей Ж. и Бокиев Б.

Aging wooden carcass structure, supportly picture with back was unmounted, for the reason change their new metallic framework. This new framework was made from steel profiles welded between itself. The holes were made In framework for lavalier aluminum sheet with picture. On noted framework 3 greater aluminum sheets Took seats with sizes 10,93 h 2,5м. and with - 3,63, 4,37, 2,93м and height on 2,5 metres.

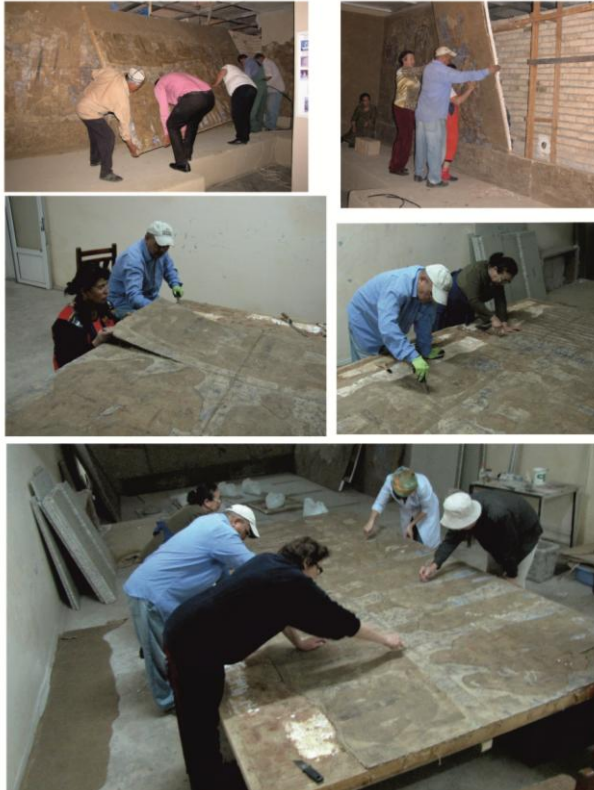
таблица-2

Снятия старых щитов со стены с росписями
по крупным кускам

For begin left the shields with wall by large parts. On even horizontal surface fragments layer painting cut on piece, where there are buttings mastics. Neatly finished with scalpel with polished fragment. Have Avoided the sackcloth with surfaces painting by means of alcohol, where much tightly was taped. Was restourated card face, have cleared the colorful layer, have attached the pockets by polymer, mastics where required and have closed the rift. The Edges mastics, ready fragments were stuck on new, aluminum profile true cause. The New base firm that that she is not deformed, wetfirm, frostfirm and light, for good time-proof safety unique painting Afrasiab.

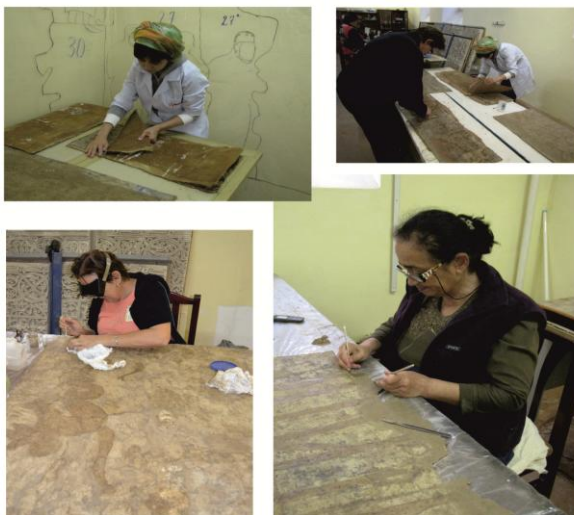
таблица-3

Реставрация фрагментов росписи по частям

на фотоснимках: работа над реставрацией фрагментов росписи
археологи-реставраторы - Реутова М., Ахадова Г., стажер- Султанова М.

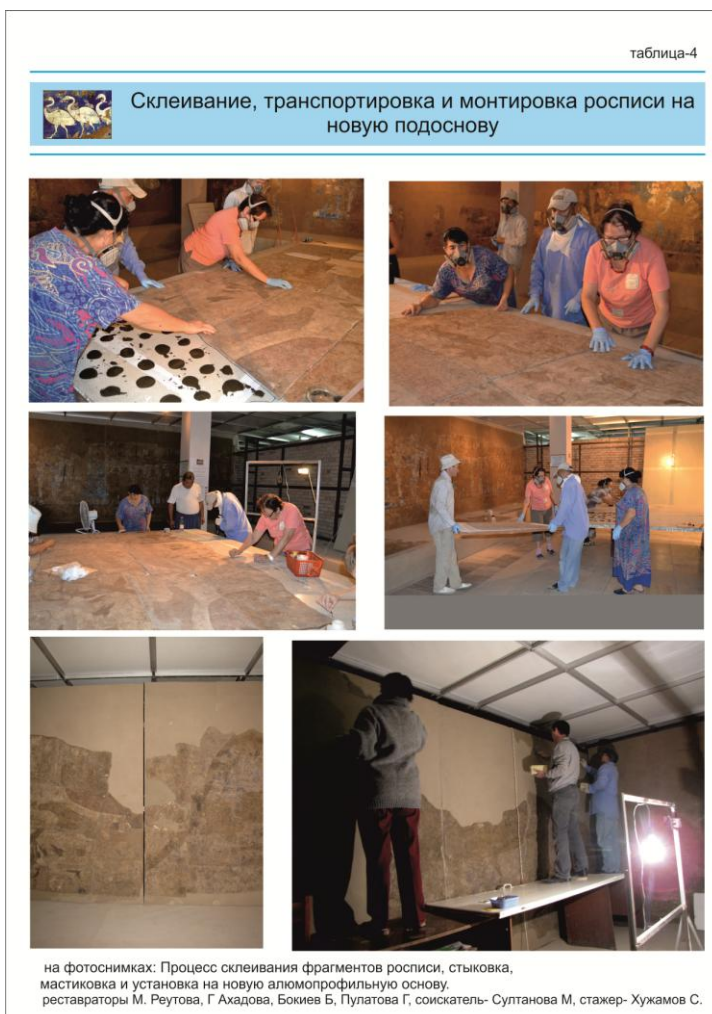
The Workshop in museum of Afrasiab. First of all, during the first decads of May 2015, before beginning of the work, were organized two workshops on reconstruction in cellar museum, as

The Process of the reconstruction painting and organization worker ambiances. The Workshops are provided by blocking door museum, as well as were sealed up in each night. The Electric systems on generator were is also installed assotiation (ASPA), for maintenance of the work, in the event of potential power reductions.
