# **Calculation of the Load-Carrying Capacity of spans when reinforced with a14 (vehicle load) and NK100 (wheel load) loads**

**ABSTRACT.** The paper presents the calculations of the spans, taking into account the strengthening of the supporting sections of the beams, checked their carrying capacity, whether it is sufficient to pass the modern load A14 (vehicle load) and NK100 (Wheel load) by ShNK (Urban planning rules and regulations) 2.05.03-12. "Bridges and pipes". It has been shown that reinforced concrete structures with an emergency risk more than 0.1 should be replaced, and structures with an emergency risk less than 0.1 are repairable and can be restored. It is practically impossible to reinforce the supporting elements of the overpass to the level which meets the requirements of passing the modern loads A14 and NK100 and requires enormous material expenses which are probably commensurable with the cost of erecting new overpass.

Road overpass for the entrance to Gulistan from the highway on the 117+150 km of the M34 highway " Tashkent-Dushanbe".

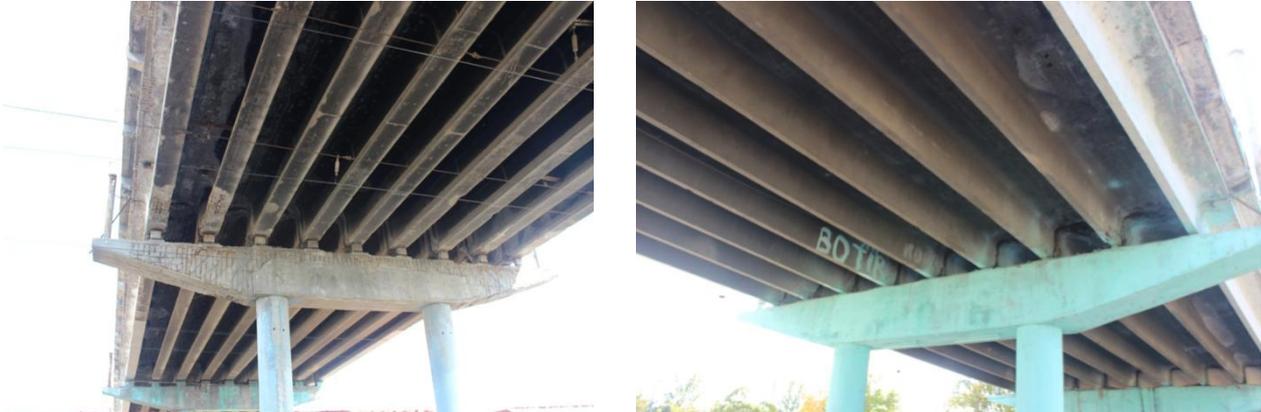
There are 9 beams with the distance between the axes of 1.65-1.70 m in all the spans of the overpass. The girder joint at the level of the slabs is made with monolithic concrete (photo 1).

**Photo 1. General view of the spans from below**

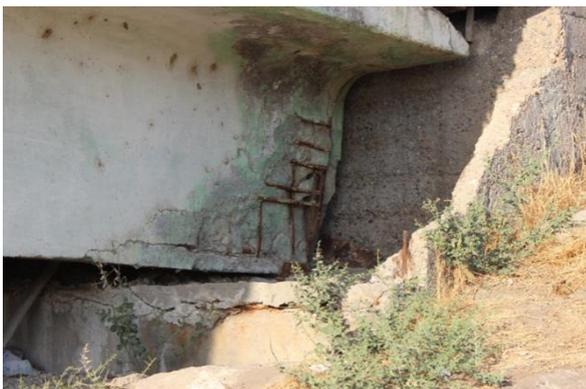
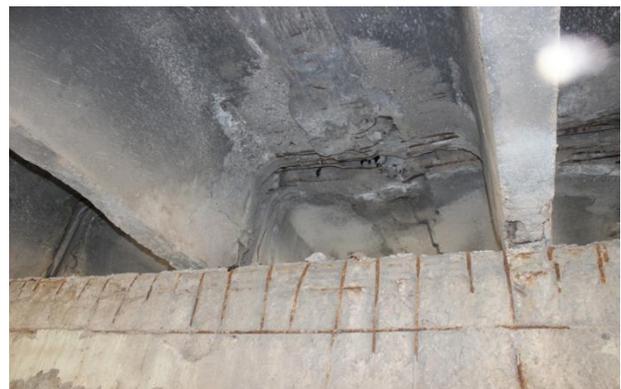
**Photo 2. Span №1. Damage to the supporting sections of the beams**

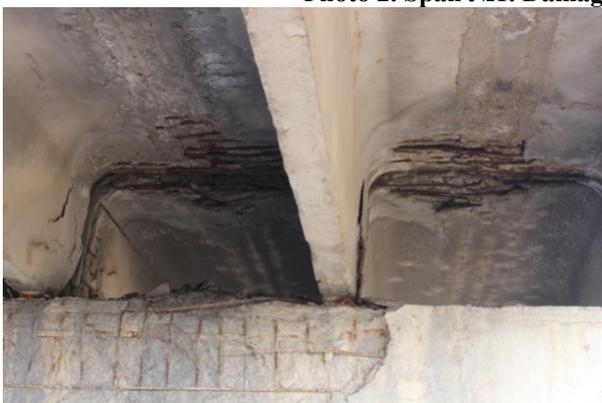
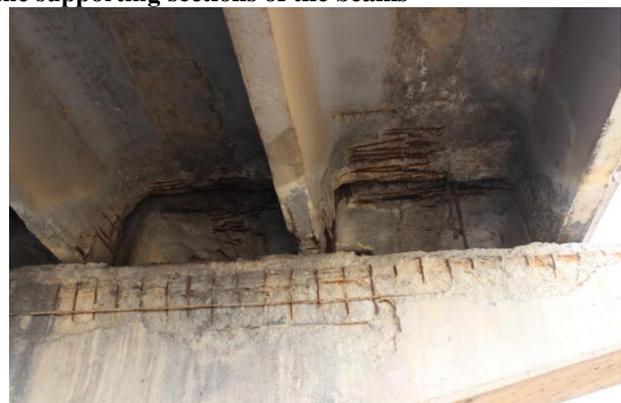
**Photo 3. Span №2. Damage to the supporting sections of the beams**

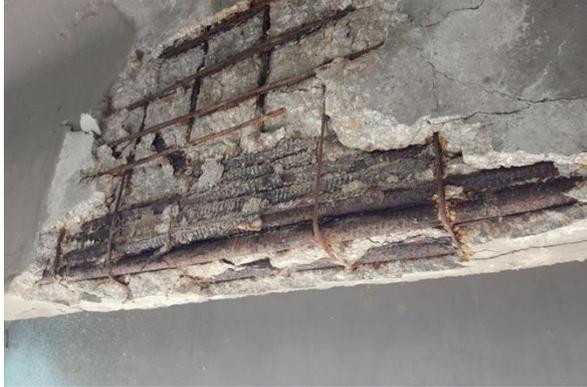
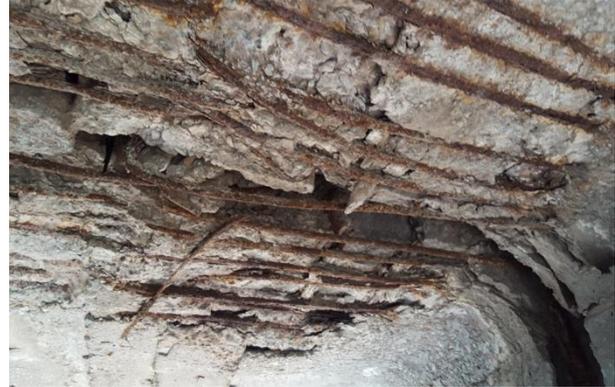
**Photo 4. Corrosion of bare reinforcement at the sites of destruction of the protective layer of concrete in the beams of the span with  $L=16.76$  m: (a) section of the beam near the drainage tube; (b) section of the slab near the expansion joint**

According to the results of selective dissection of the reinforcement, it was found that the ribs of the beams in the middle are reinforced with 12Ø32AIII. The actual concrete class in the undamaged sections of the beams is B30, in the monolithic sections - B20. In all spans of the bridge, bridged by beams  $L=16.76$  m, the support sections of ribs and slabs are damaged:

- the protective layer of concrete has been lost,
- the concrete and the reinforcement are corroded,
- the reinforcement lost its bond with the concrete,
- the concrete of the slabs has deteriorated,
- the reinforcement of the plates is torn and deformed in some places.

There are vertical and inclined cracks up to 0.3 mm wide in the beam ribs. Longitudinal cracks have formed on the supporting sections of the beams on the lower surface of the ribs. There are traces of leaching on the surface of the beams.

The length of the damaged support sections of the beams is mainly up to 0.5 m, in some beams - up to 1.0 m. The depth of the carbonized layer of concrete in these sections is 30-50 mm. The degree of lamellar corrosion of the reinforcement is up to 15%. Unacceptable deflections of the beams were not detected.

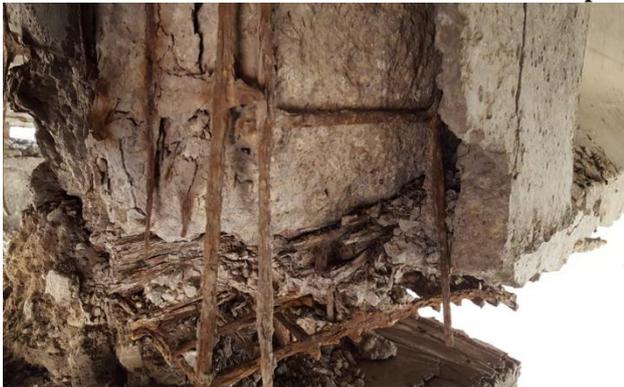
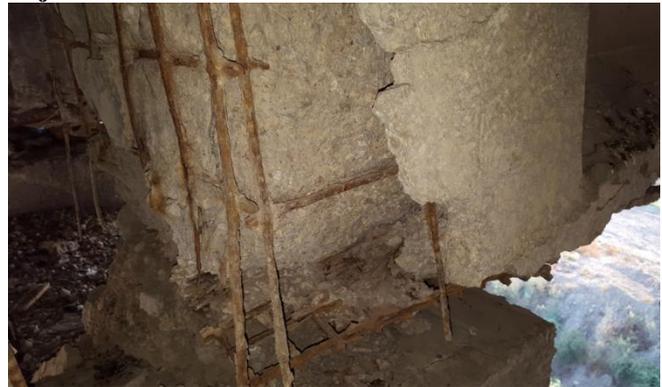
**Photo 5. Fracture of concrete and corrosion of reinforcement at the ends of beams with  $L=22.16$  m**

The actual concrete class on the undestroyed sections of the beams is B30, the monolithic sections is B25. In the bridge spans overlapped by beams  $L=22.16$  m, the support sections of ribs and slabs are damaged:

The protective layer of concrete has peeled off and bulged,  
 The concrete and reinforcement are corroded,  
 Concrete of the plates is destroyed,  
 There are traces of leaching on the surface of the beams,  
 The length of damaged support sections of the beams ranges from 0.3 to 0.8 m,  
 The depth of carbonized layer of concrete in these sections is 30-50 mm,  
 The bare reinforcement in the ends of the beams is corroded,  
 The degree of corrosion is up to 10%.

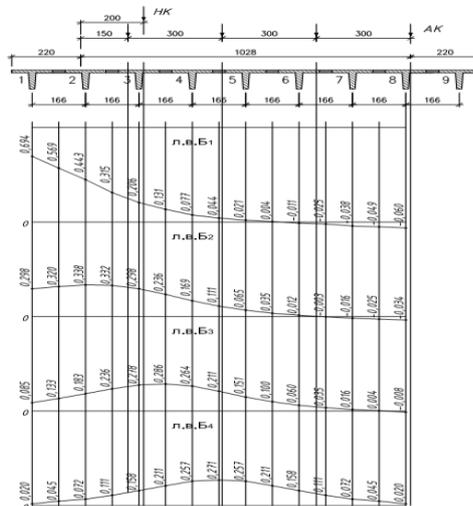
The lines of influence of pressures on the beams are plotted as lines of influence of support reactions on elastic supports [7, 9] and are shown in Pic. 1.

**Pic. 1. Scheme of loading of span structures**

Loading is done for three circuits:

- 1) the two A14 loading lanes are as close to the safety barrier as possible;
- 2) the two A14 load lanes are as close to the edge of the roadway as possible and combine with the crowd on the sidewalk;
- 3) NK100 load at the edge of the roadway.

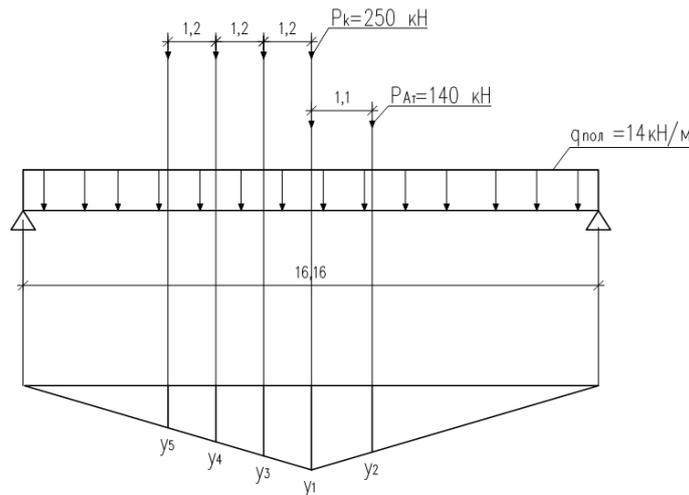
Determination of the maximum bending moments in the middle of the span.  
The construction of the influence line is shown in Pic. 2.

Pic. 2. Influence line of the determination of  $M_{max}$
