# **Problems In Exploiting Hydrotechnical Engineering Structures: Solutions And Suggestions**

**ABSTRACT:** Operating hydraulic structures in the country were built in the second half of the last century, and their technical reliability has been declining as a result of many years of maintenance and inadequate repair and exploitation. This article presents the results of research on the Langar flood reservoir. Proposals on ways to eliminate and mitigate identified problems are provided.

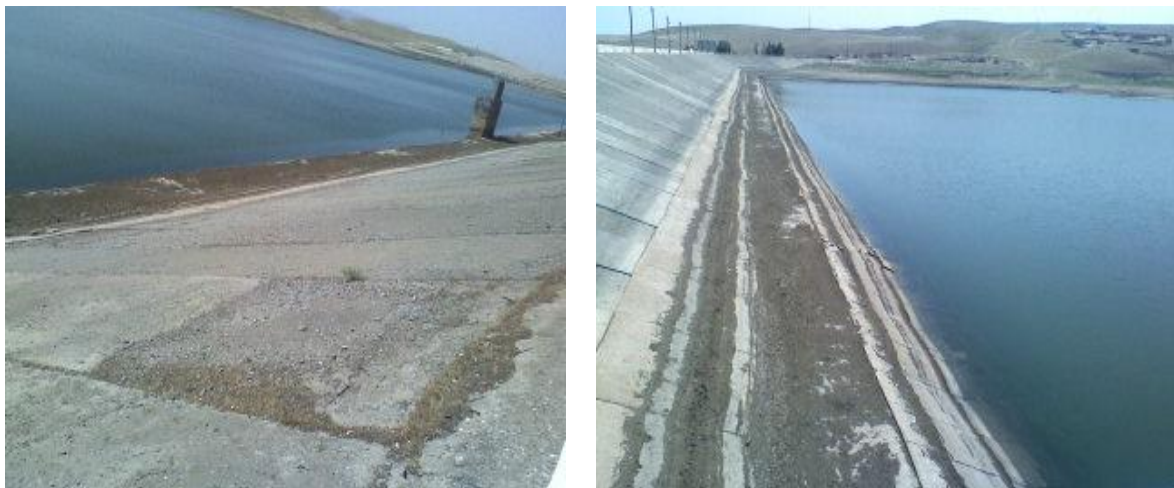
Together with scientists from the Irrigation and Water Problems Research Institute, the Langar flood reservoir is located 15 km away from center Kamashi district of Kashkadarya region. As a result of this work, the following information was obtained: reservoir filling started in 1975, with a total water intake of 7.35 million m<sup>3</sup>. The source of replenishment of this structure is Langardarya. As a result of the study, it was found that the reservoir was still filling due to the sedimentation. The current technical condition of all HTS at the Langar flood reservoir management department was determined by the dam: length - 1100 m; width of upper part - 6 m; height - 34 m; high slope - 2,5; 2,75; low slope - 2,5; 2,75; 3.0. The upper part of the dam is in satisfactory condition, the upper slopes are covered with concrete slabs and parapets are installed at the top. The waves caused by the wind and the discharge of the reservoir at the slabs caused some non-hazardous fractures and faults in some areas. There was an increase in different grasses on the slopes of the dam (Fig. 1).

Figure 1. Defects in the pressure slope of the dam
